## SUSTAINABLE CONSERVATION ISSUES OF FOUR 14TH AND 15TH CENTURY MOSQUES IN ANKARA: AHI ELVAN MOSQUE, ÖRTMELİ, SABUNÎ AND POYRAJLI MESJIDS

Evin ERDER

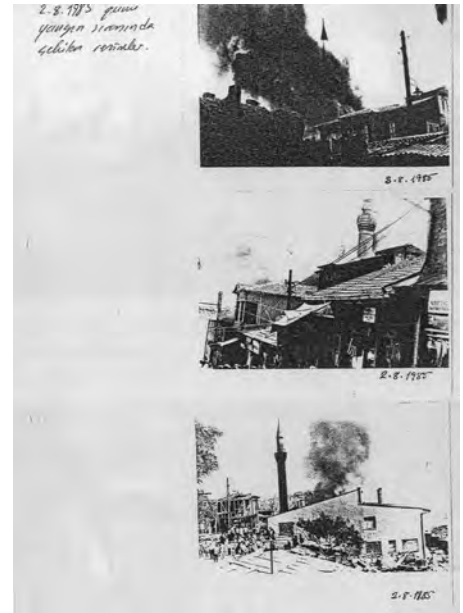
**Figure 8.** Ahi Elvan Camii, during fire at adjacent shops in 1985 (VGM Archives).

Each of the four structures underwent various changes during their restoration, conservation and maintenance during the 20th century. Based on archival records, it is known that Ahi Elvan Camisi was restored substantially during the late 1960s or early 1970s when its mud brick bearing walls were repaired and re-faced with brick and cement-based cladding (16). Its *mimber*, also re-painted with oil-based paints by the 1970s (17) remains so today. Its original timber *mimber*, or pulpit, on the other hand, has remained in a deteriorated condition since the 1970s (18). In 1985, a fire took place in an adjacent cotton shop burning surrounding shops to the ground, an event documented by many photographs now at the VGM Archives. Fortunately, this fire only scathed the west side of the building.

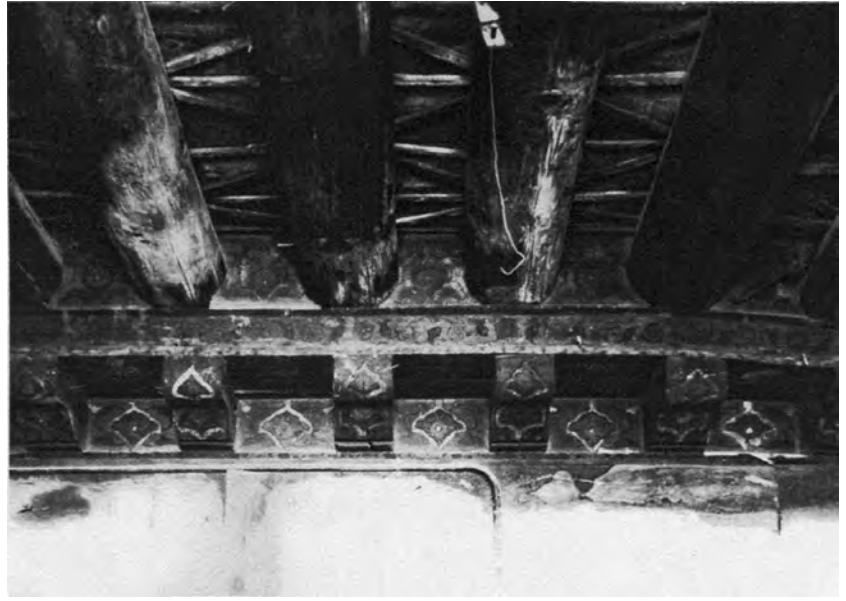
**Figure 12.** View of timber ceiling of Poyrajı Mesjidi before its restoration.

Örtmeli Mesjidi appeared the most neglected. Unlike the other three structures, its timber ceiling had cracks and most of its *kalem işi* decorations had disappeared over time. Recognized as such, this *mesjid* underwent major restoration and conservation work which fundamentally changed and transformed its physical condition and appearance. A complete survey and graphic documentation of the building and its decorative motifs at both at its timber ceiling and cast stucco *mihrab* by Aktan and Aktan (2004), accompanied by their recommendations for restoration work, was approved by Kültür ve Tabiat Varlıklarını Koruma Bölge Kurulu of Ankara. In the fall of 2006, restoration work began at the *mesjid* which involved both preventive measures such as the installation of a new water drainage system, as well as re-painting of its *kalem işi* (pigmented embossments). In addition, removal of all previous paint layers from its stucco *mihrab* revealed its original motifs facilitating its total restoration by the completion of missing areas with cast stucco.

Poyraji Mesjidi was restored completely by VGM between 1971 and 1975 (25). In an old photograph, taken prior to its restoration in the 1970s, its walls were timber-frame with mud brick infill. This *mesjid* also had stucco window frames with stained glass windows, later replaced in the 1970s by cast concrete windows similar in form and appearance to their originals (26). In 1971, during the construction of the Hacettepe University campus, a report by two art historians, Bilcen and Bayburtluoğlu, dated September 8, 1971, requested the registration of this structure as an historic monument (27). The report declared that the most valuable part of the *mesjid* was the timber projection of its women's section, or *kadınlar mahfeli*, and its *kalem işi*, or pigmented embossments. At the time, its *aşı boyası* or natural pigments had "different tones of green, orange, yellow, white, turquoise and *vişneçürüğü* (cherry red)" (28). Its timber ceiling also featured *kalem işi* which "perfectly reflecting the taste of their time" (29). This report thus ensured the registration of Poyraji Mesjidi as an historic monument worthy of protection and conservation. As a result, on September 15, 1973, Gayrimenkul Eski Eserler ve Anıtlar Yüksek Kurulu (Committee for Immovable Historic Works and Monuments) decided that Poyraji Mesjidi would be restored (30). Its restoration involved partial removal and replacement of its deteriorated mud bricks and tie-beams and re-plastering of the building entirely with cement-based cladding as well as replacement of its timber ceiling with a new one resembling its original.

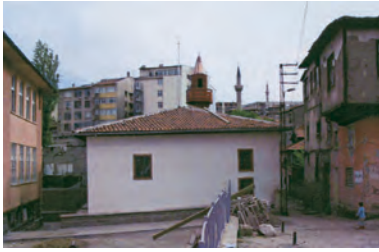
Figure 13. Örtmeli Mesjidi, after restoration work, April, 2007 (Photo: E. Erder).

Restoration work at Örtmeli Mesjidi, completed by April, 2007, thus changed and transformed the structure entirely (Figure 13). Its ceiling, re-painted in selected areas, its stucco *mihrab* restored, its interior and exterior wall surfaces re-painted with a white limewash, its minaret replaced and conical cap re-clad with copper and the new chandelier within the *mesjid* created a sense of “newness” at the *mesjid* (Figure 14-15).

Removal of all its cement-based cladding and interior plasters followed by the installation of a new water drainage system at its foundations and application of new clay-based plasters, both at its interior and exterior wall surfaces, has fundamentally changed the physical characteristics of its bearing walls and reduced the likelihood of rising damp. The application of clay-based renders, composed of a mixture of soil and whitish clay obtained from Balâ, an administrative district within the province of Ankara, also reflects current awareness of the importance of physical compatibility of materials used in restoration with original materials and their sustainability. However, as is customary, the project, initiated when funds became available, began in the late fall and winter. Consequently, its interior, exposed to the cold climate, required a heating system used during working hours. Other repairs involved the replacement of its roof drainage system, as well as its timber minaret and conical cap, re-clad with copper sheeting, and replacement of window casings with new casings and installation of double-paned glass. Within the *mesjid*, a new sub-floor heating system replaced the portable, gas and/or electrical heaters commonly used in such structures. The timber balcony of its women's section (*kadınlar mahfeli*), entirely removed during restoration work, was later replaced by a new one.

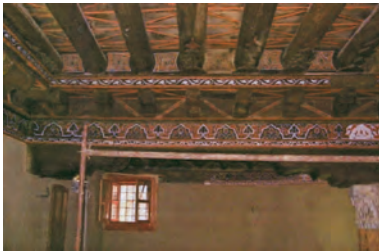
Figure 14. Örtmeli Mesjidi timber ceiling, after re-painting (Photo: E. Erder).

selected areas with matching colors. During this process, the cast-stucco *mihrab* was also repaired and restored with cast stucco matching its original geometric and floral motifs. Repair and re-painting of the timber ceiling involved the following steps (31).

Broken or cracked timber elements were removed, stapled at the back and reinforced with cloth and *ağaç tutkallı*, an organic adhesive. Missing *hançer*, or dagger-shaped timber elements and timber laths were replaced by newly carved pine elements. Subsequently, areas of the ceiling with their original pigments still present were coated with an *astar*, or undercoat of linseed oil, followed by all other areas due to be re-painted. The *kalem işi* (pigmented embossments) were then re-painted or reproduced in selected areas by first re-drawing the pattern of each decorative feature, filling each with a suitable color made of a mixture of *toprak boya*, or commercially available natural pigments, followed by contour-lines around each feature. It also became apparent that two different brush-strokes were apparent during re-painting: one very smooth and skillful, possibly that of the master-craftsman, and the other, apparently less skillful, possibly belonging to his assistant. One decorative element, placed in reverse, may have been placed as such intentionally. After all re-painting was complete, all timber elements within the *mesjid* were coated with at least three layers of shellac, called *gomalak* diluted in alcohol.

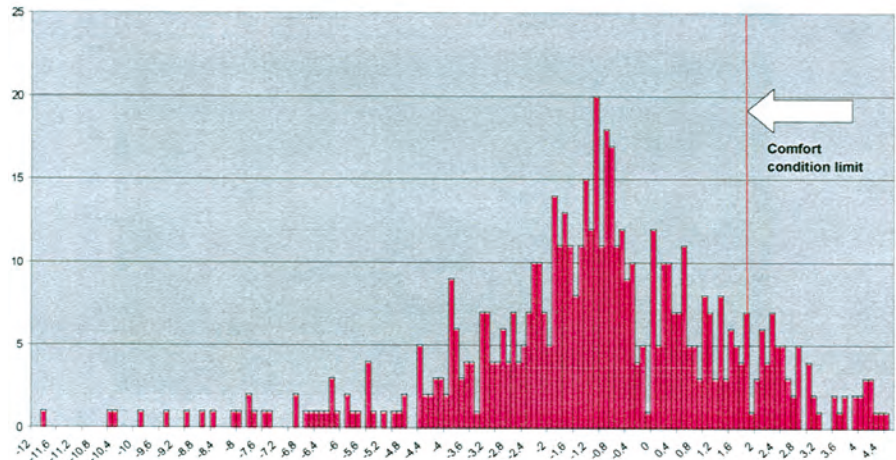
Figure 23. Dew point temperature frequency distribution at Sabunî Mesjidi in January, 2007 with respect to comfort condition limit.

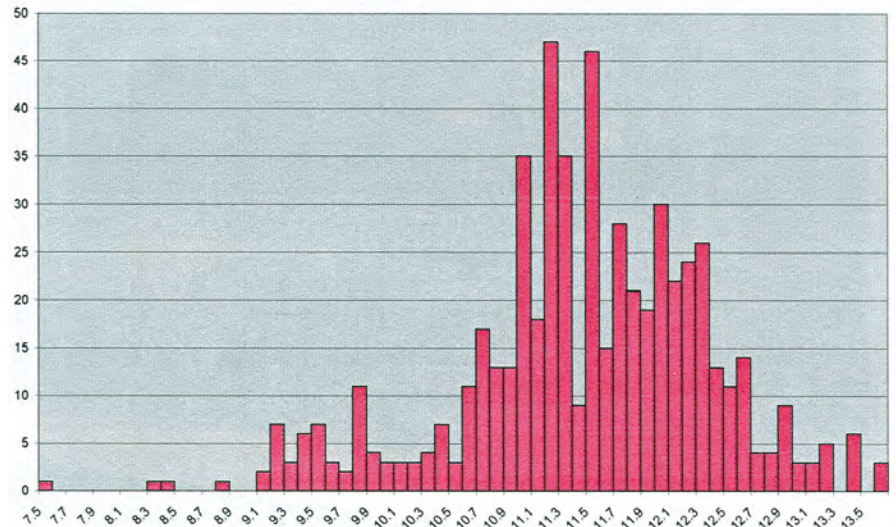
Figure 24. Dew point temperature frequency distribution at Sabunî Mesjidi in July, 2006.
