## WALL PAINTINGS OF NECİP ÖZALP HOUSE IN GESİ (1)

Vacit İMAMOĞLU and Çağrı İMAMOĞLU

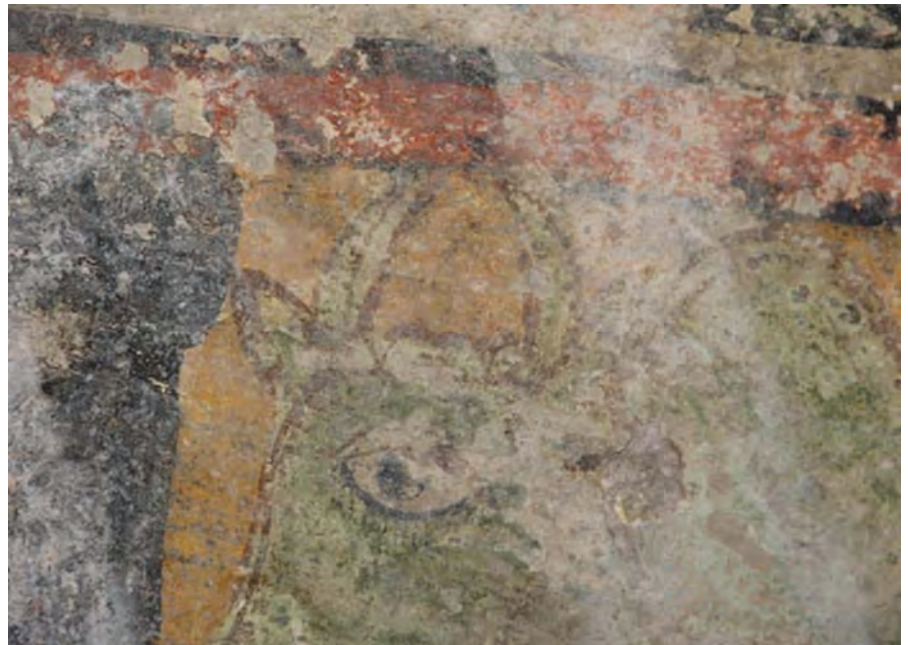
**Figure 1.** “A bull,” wall painting from a rock-hewn church in Değirmenderesi Valley near Darsiyak village.

The paintings examined here represent in a sense the continuation of a long tradition that survived in that vicinity. Some wall paintings still exist in volcanic-rock-hewn spaces in the region, near the village of Darsiyak (Figure 1). They are from the middle ages and are quite similar to those we come across in underground spaces in Cappadocia. After examining the still life and landscape paintings of the walls of a house built in 1825 in Göreme (in Cappadocia), Renda (1985) pointed out that those paintings were the products of a talented artist. Renda (1976) also examined wall paintings and decorations on the timber wall panels of the "başoda" (major room) of a house built in 1808 in Büyükbürüngüz (which is near Gesi). She stated that these paintings also reflected a high level of understanding of

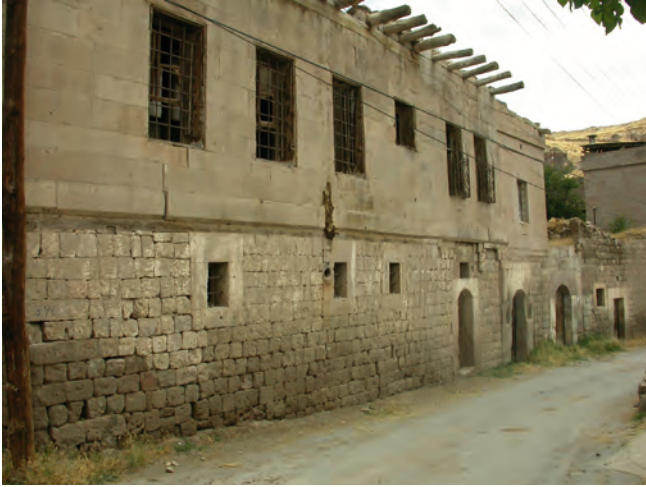
Figure 2. South elevation of Necip Özalp House, Gesi.

This house is located in the 'south neighborhood' of Gesi. It is a late 19th or early 20th century building (Figure 2, 3). Its ground floor was allocated to a courtyard and service spaces, and upper level to living. The largest room on the first floor, most probably the reception or selamlık room for male guests, is an elongated rectangular space, parallel to the street (Figure 4). Its three windows are oriented towards Üç Havuzlar Street, in the south. It is entered from the east side. Its west wall houses a fireplace and flanking cupboards, while the north wall is solid. Rectangular frames of different sizes (ranging from 80x80 cm to 80x110 cm), covered with various paintings, were cemented on the wall surfaces using a 4.0 cm thick mud plaster all along the north wall and between the windows in the south. There are four of these frames on the north wall, and three on the south wall. The large frames have straight lines and they are decorated with floral motives on each corner. Each of these frames further had an inner frame either in ellipsoidal or circular form, in which a picture was painted. These paintings have different themes and compositions. Three paintings depict nature (forests, mountains, rivers and the sea, sometimes including houses), another three portray townscapes or buildings (houses, churches, a mosque, and a bridge), and one painting is a still life. Below, each painting in the room is briefly described, in a counterclockwise order, starting from the east end of the north wall.

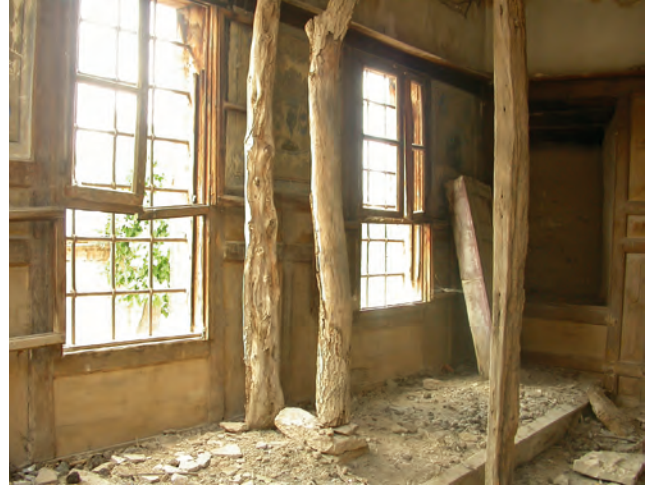
Figure 3. Interior view of the *başoda*.

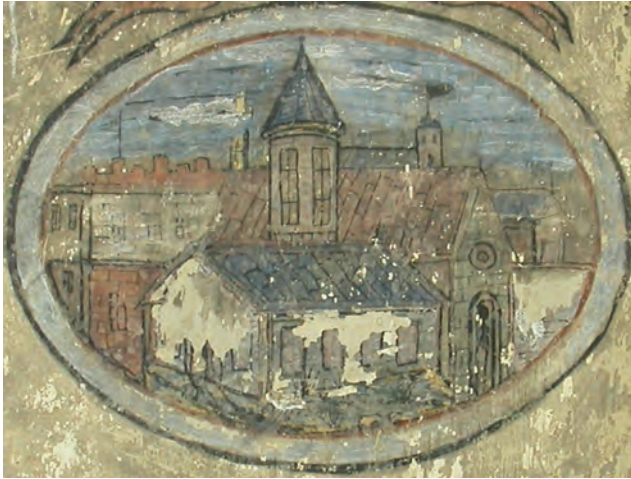
Figure 5. Painting 1, on the north wall.

The first wall painting on this wall depicts a townscape scene, a European kind of cityscape with churches, towers and flags. A square-shaped outer frame holds a horizontal ellipsoidal frame of brown and black lines infilled with blue, which houses the painting. The foreground of the painting

includes a single-storey building with four windows on its right side, a symmetrically arranged (probably) central door, flanking windows on the triangular facade with a hipped roof in blue (Figure 5). On the upper portion of the roof, there is a tall, cylindrical tower, which is located in the center of the painting and positioned just behind the roofline. Its relation with the building, however, is not clear. It has two tall windows and a conical cap. On the right hand side of the painting, there is the entrance door of a stone building (most probably a church) with a steep triangular roof, an elegant gate and a circular window on top of this gate. The red colored roof of this building ends just before the hip of the single storey building mentioned above. The left hand side of the painting includes one or two house facades that may be two adjacent houses or two facades of the same building meeting in the corner. These facades indicate that the building(s) is (are) two-storey high. The first facade has a white surface and three windows on its upper level. The facade of the lower level, on the other hand, is painted with red and only one of its windows enters the scene. The lines here indicate that it was built of stone. Two lines separating these two levels might be an indication of the projection of the upper level towards the street. The second facade is also a two-storey one, painted in gray on both levels. It has two windows on the upper level and one on the lower. Two continuous lines that probably indicate a parapet, end the rooflines of these two facades. Above the upper line, one comes across a red band, including approximately six chimneys. These elements however, give an ambiguous impression to the onlooker because they may very well be towers of a city wall in the far distance.

The background of the painting includes a building with a hipped roof on the right side and a flag near its rooftop. Then come the tower (probably a cylindrical one) and the roof of a large building, which are seen just above the church. The tower has two windows, (probably) a door symmetrically located on its facade and a large dark colored flag waving on a pole located in the center of its conical roof. The next element on the scene is on the left side of the large cylindrical tower; it is a yellowish slender tower with a square or elliptical plan. This latter one may be a clock tower, but since this portion of the painting is partly destroyed, it is difficult to tell. The last element on the left side of the painting is a pole, probably holding a triangular flag. However, the directions of flags on the painting are not consistent: While the flag in the central position waves toward the right,

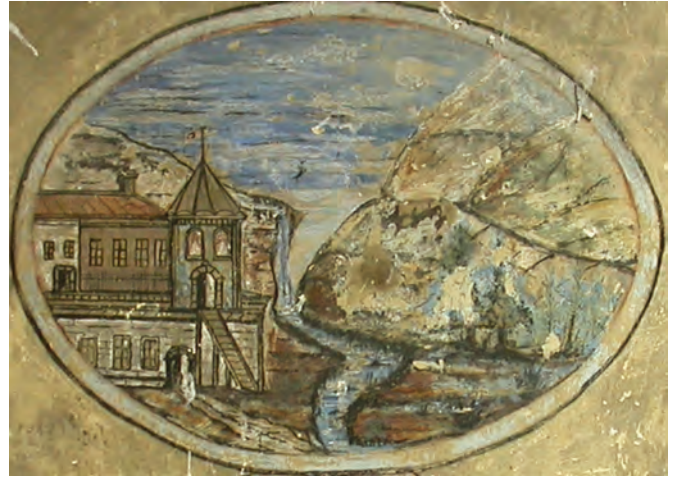
Figure 6. Painting 2, on the north wall.

The second painting was painted inside an ellipsoid frame, which is horizontally placed in the center of a horizontally laid rectangular outer frame. It is a landscape with houses. The picture plane is divided into two sections by a centrally located water stream at the center (**Figure 6**). The stream starts from the left hand side: it falls down from a cliff, and flows down towards the foreground of the painting by a smooth turn in the middle. The portion on the right side of the stream is divided into two parts: A bulky, steep mountain covers most of the surface. It is painted in yellow, brown and red. A diagonal black line indicates a path or a road climbing up towards the middle hip of the mountain. On its skirts, one can see a large tree and (probably) a house; then comes a plain in their front side including a variety of landscape elements painted in red, brown, green, blue and black. The left side of the stream is allocated to a large two-storey house complex. A pathway from the stream leads to an arched door of a building on the ground level. Its beige facade has a door on the right side and has three rectangular windows on the left side of this door. The lines on the facade indicate that the walls of this level are made of stone. A ladder (or a wooden staircase), supported by three slender columns, leads up to the upper level of the building. These stairs, however, do not have any balustrades. They end up in a landing in front of a two-storey entrance tower which seems somehow connected to other buildings located on its left side. The entrance tower has a symmetrical facade; it has an arched door on the lower level and two arched windows on the upper. There is some indication of reddish curtains on these windows. The entrance tower block is covered with a steep polygonal (or conical) roof, painted in brown. The pole erected in the center of the roof of the tower carries a flag with a crescent and a star.

On the left side of this tower, there is a large mass of a building, the front of which has a continuous line of balustrades. The building mass here is divided into two; the one next to the tower has a brown facade and four rectangular windows. The adjacent building facade on the other hand, is painted in beige. It has a door on its right side at the entrance level and two windows on its upper level. These two facades -although the first building is a one-storey, and the latter one is two-storey- are connected with a single roofline and a cornice. The roof is sloped and painted in red; it has a large chimney with a smoke. The chimney is located on the right (side), just at the very end of the gable. The triangular space left between the two main parts of the painting is depicted as sky and painted in blue, shades of purple, green and beige.

Wall paintings of the house were generally produced according to the rules of perspective. However, there are some minor inconsistencies in some of the details, like a single and a double-storey building having equal heights (painting No: 2), and the over-scaled house on the island (painting No: 7). Two of the seven paintings, on the other hand, seem to have a two-dimensional character. These are the mosque (painting No: 4) and still life paintings (painting No: 6).

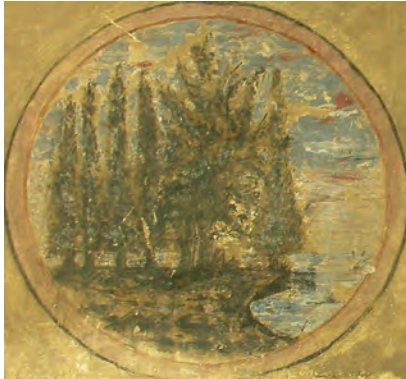
Figure 7. Painting 5, on the south wall.

The fifth picture was painted on the surface near the cupboard of the fireplace of the room. It is a landscape scene with a forest (**Figure 7**). The painting has a rectangular framed placed upright, and a circle surrounding the composition. Five tall pine or cypress trees and (probably two) deciduous trees are densely planted near a lake or seashore. On the right hand side there is a small bay, and in the center and the left side of the painting plane -in front of the trees- there is a piece of empty land. Trees and land are painted in green, dark green, red-brown and blue. Behind and

above the trees, a blue-gray color was used to indicate the sky or perhaps, the continuation of the water body behind the group of trees.

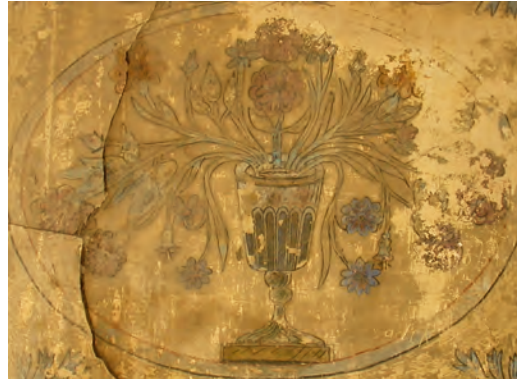
Figure 8. Painting 6, on the south wall.

The sixth painting is a still life, composed of flowers in a vase. A horizontal ellipsoid frame surrounds it (Figure 8). The flowers are arranged almost in a symmetrical fashion on a yellow-gold background. Though most of the colors faded away and turned into yellow, we can still see patches of blues and reds on the flowers. The vase has a classical appearance; it stands on a base, has a leg and a fluted body giving the impression that it is made of glass.

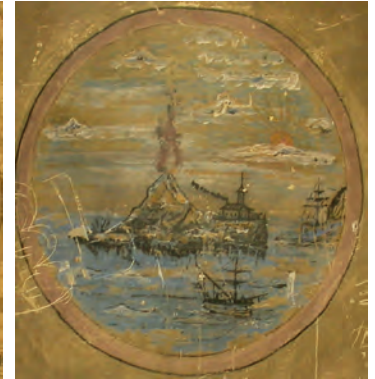
Figure 9. Painting 7, on the south wall

The seventh painting has an outer square and a circular inner frame. It is a sea-view depicting various natural and human-made elements (Figure 9). In its center there are one or two islands with an active volcano on the left side. If it is a single island, on its right side is a high plateau where a building is located. The volcano has a sharp conical shape that comes down towards the seaside on the left and front sides and its skirts seem to be covered with plants. Its smoke starts from two different points on its summit. The right side of the island (or perhaps the second island) has a single-storey building, which is surrounded by hedges. The building has a sloped roof, and a tall slender tower behind its roof. One of the facades of the building has two, while the other one has three windows. The roof of the house is painted red and has a chimney on the left end, from which a cloud of black smoke comes out toward the left. The above-mentioned tower has two openings, a triangular roof and a big pole on which a flag weaves.

In the sea, there are two ships in the front right and on the far right hand sides of the island with their sails down. The ship on the far right is a larger one. The sea is painted in blue and white, yellow, black and brown patches of color depicting waves. The sky, on the other hand, is painted in yellow, green and terra cotta colors with some white clouds. This sky, covering more than half of the picture plane, includes an orange colored sun on its right hand side, just between the building and the larger ship. The lower part of the sun is masked with a cloud, while the upper part protrudes orange sunrays towards the top of the sky.
