REPAIR PHASES OF SULEYMANIYE COMPLEX IN DAMASCUS

Neriman ŞAHİN GÜÇHAN*, Ayşe Esin KULELİ**

Keywords: *Süleymaniye* Complex in Damascus; *Mimar Sinan*; Ottoman; restoration.

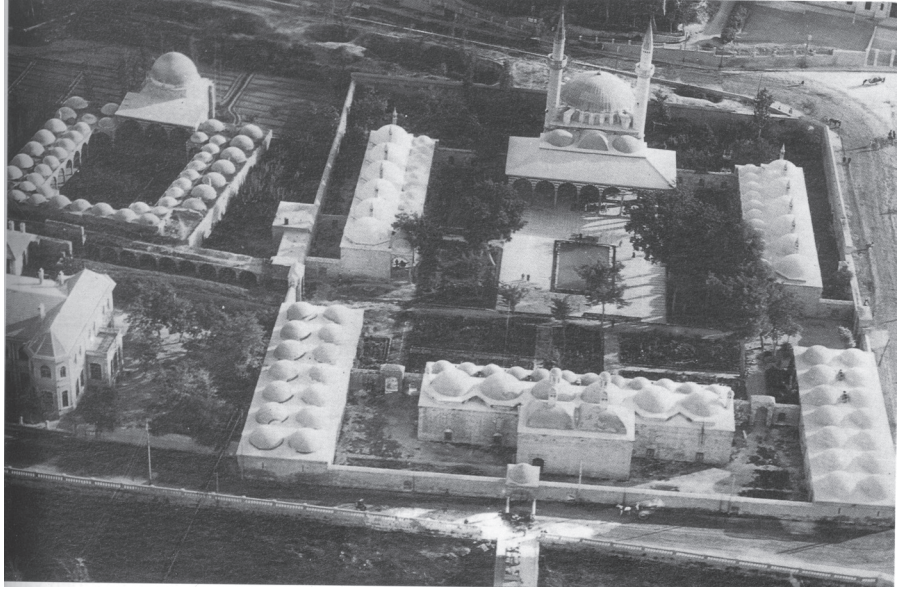
Figure 8. DSC; view from north (Kuran, 1986, 69).

aligned with the gate of the *Imaret* in the north. The bridge seen in the photograph published by Kuran in 1986 does not exist at present (Figure 5-6, 8, 13c).

The courtyard gate having a depressed arch made with dichromatic stones at the eastern side of the courtyard of the complex on the west entrance axis gives access to the *Arasta*. After this gate, there is the east gate of the *Arasta* ornamented with double rosettes made of dichromatic stone similar to the west gate of the courtyard in the photograph of 1868. The door opening with a depressed arched is located inside the relieving arch on the second layer of the outer surface of the gate (Figure 5-6, 8, 13d).

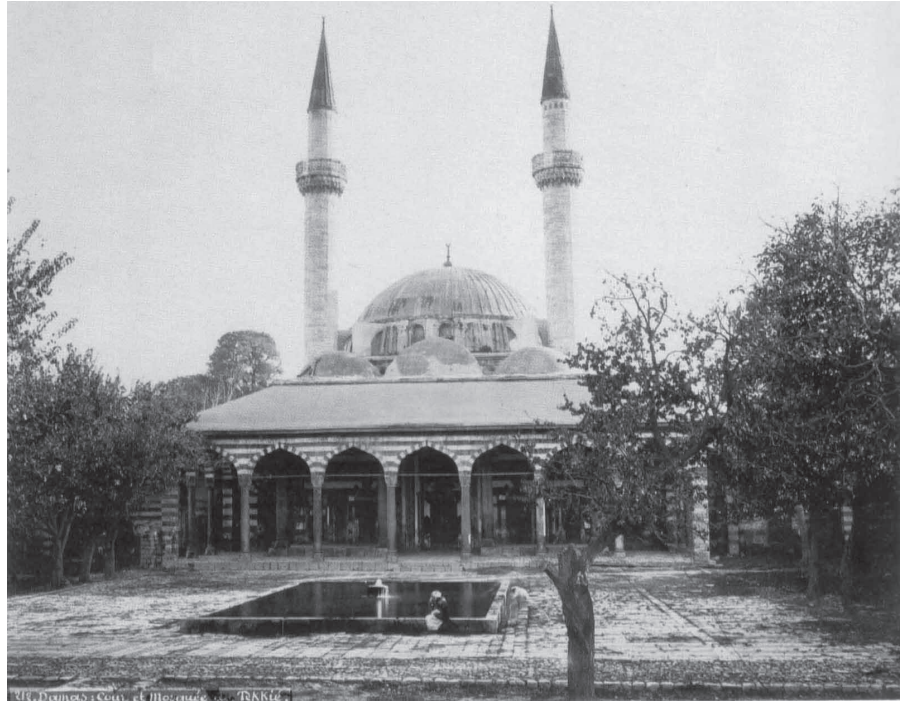
Figure 12. Takiyah Mosque in 1870. [Source: http://en.wikipedia.org/wiki/Tekkiye_Mosque]. © Wikimedia Commons. Access date (09.05.2009).

The first part of the Complex including the Mosque, *Tabhane* which is used for hosting the important guests, Caravanserai and *Imaret* are placed around a rectangular courtyard oriented on central north-south axis perpendicular to the River Barada (**Figure 9- 12**). Designed in the orthogonal courtyard order with three axes created by the Mosque and the *Imaret*; *Tabhane* and twin Caravanserai blocks at both sides this building complex shares the all features of 15th century Ottoman complexes. The double centered planning formed by the Mosque and the *Imaret* placed oppositely also defines the functional hierarchy.

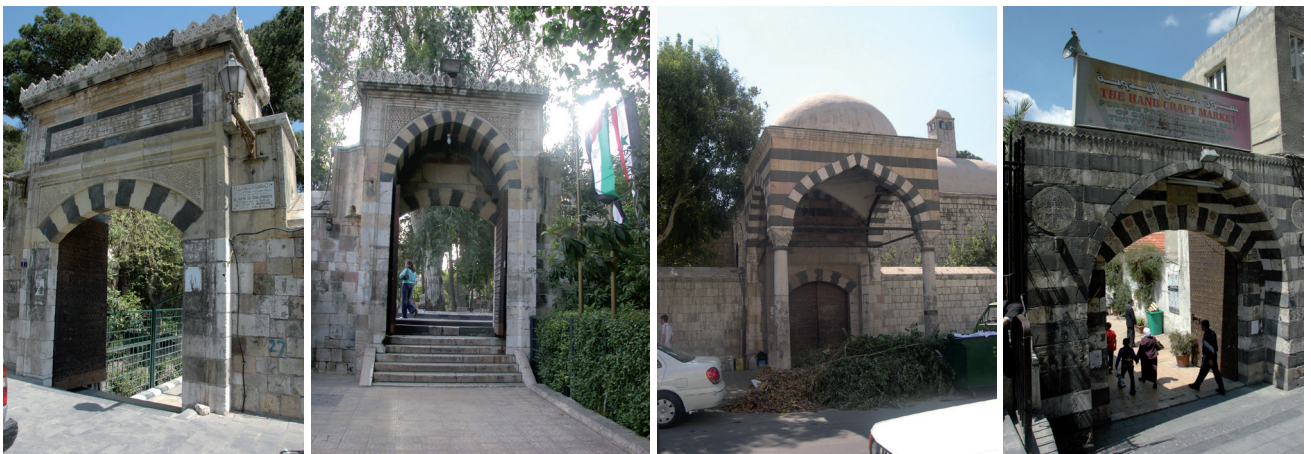
Figure 13. DSC a) Western gate (2009), b) Western gate, the courtyard facade (2005), c) Northern entrance and the single domed portico (2005), d) Eastern gate of the Arasta, 2009.

The service door to the north with its single domed portico that gives access to the courtyard of the *Imaret* and the ruins of a wooden bridge constructed on stone piers crossing the Barada can be seen in the photograph of 1868. During the landscape of the riverbank was reorganized and afforested between 1890 and 1900 a stone arch bridge with four bays was constructed

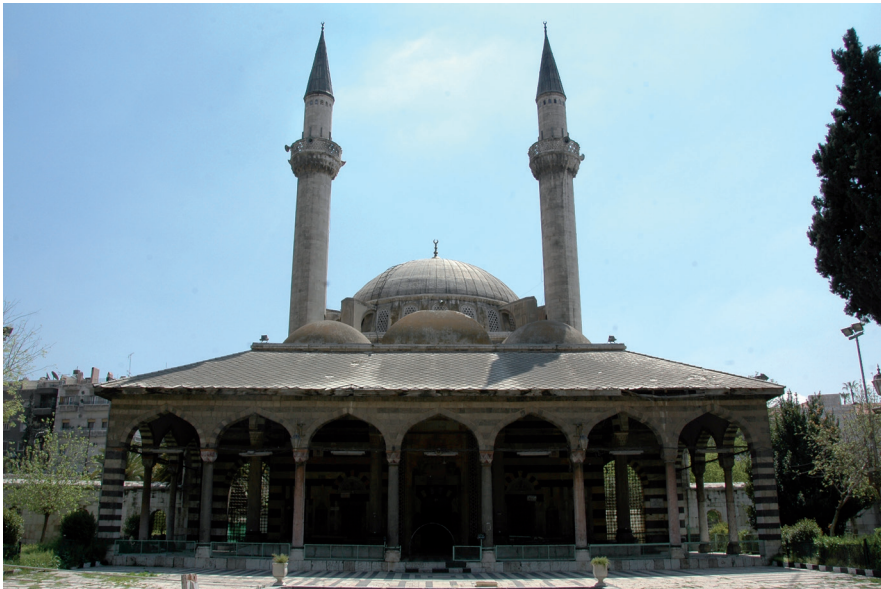
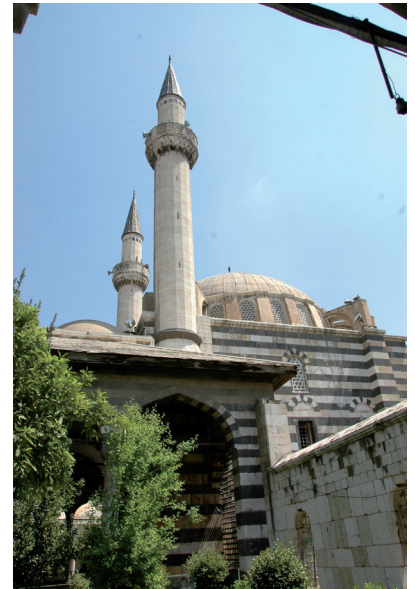
Figure 14. a) Süleymaniye Mosque and the pool; b) Western façade of Süleymaniye Mosque, 2009.

There is a shallow rectangular pool the edges of which is covered with dichromatic cut stone in the middle of the southern side of the courtyard, which is surrounded with the mosque and the porticoes of the *Tabhane*. Necipoğlu (2005, 229) argues that the fountain which allows coexistence of running water and still water symbolizes conciliation for the Hanafite and Shafii congregations inhabiting Damascus together (Figure 14).

The mosque at the centre of the Süleymaniye Complex is a plain, square planned, single domed structure with two minarets. Despite of its relatively small scale, it stands grandiosely in the courtyard with its double-naved narthex in the north of the Mosque. In the era it was constructed Aşık Mehmed, a geographer, described the mosque as one of the earliest examples expressing the Ottoman style in Damascus (Ak, 2007, 628). The main walls the thickness of which is about 104 cm are supported by the minarets located symmetrically in the two corners of the entrance facade and by corner buttresses at the mihrab facade (Figure 9- 12, 14- 16).

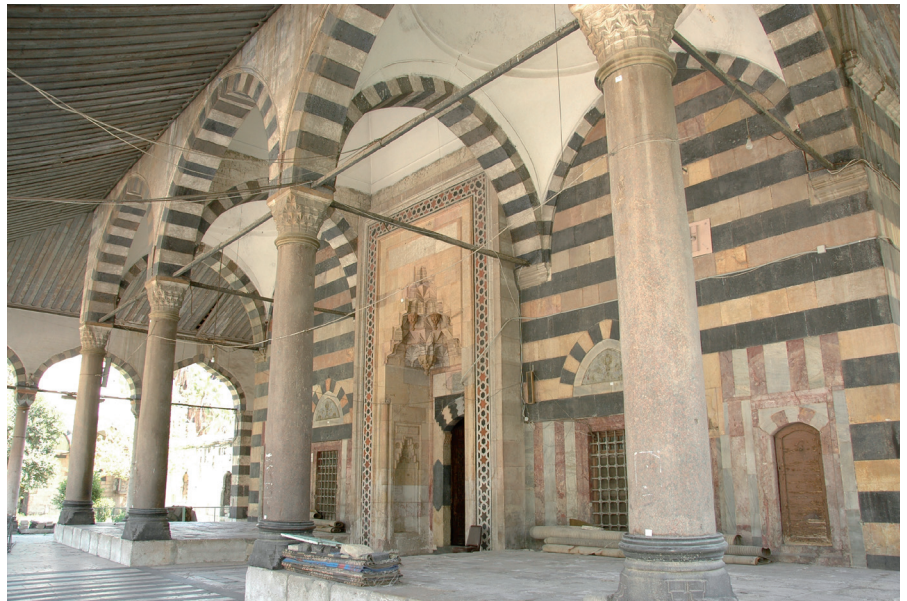
Figure 15. Süleymaniye Mosque, double naved narthex, 2009.

At the northern entrance facade of the Mosque the double-naved narthex is located. The two external parts of the inner nave composed of four pillars are covered with domes, while the section where the entrance gate is located is covered with cavetto vault. There is an inscription panel on the arch states that the date of the completion of the complex was between 1558 and 1559 (Ak, 2007, 628) (Figure 15).

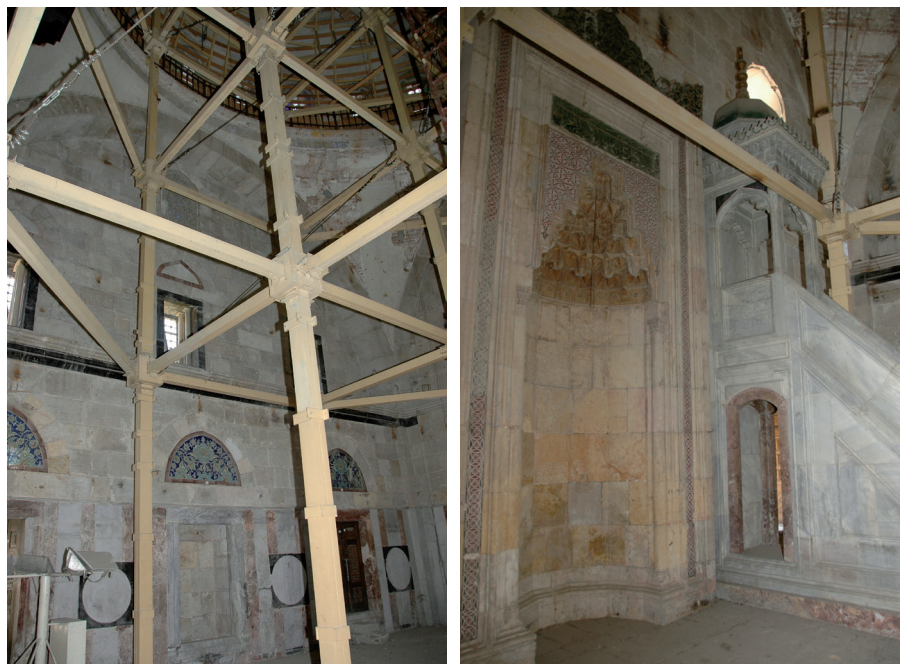
Figure 16. a) Interior space of Süleymaniye Mosque, eastern facade, b) Mihrab on the Kibla wall of Süleymaniye Mosque, 2009.

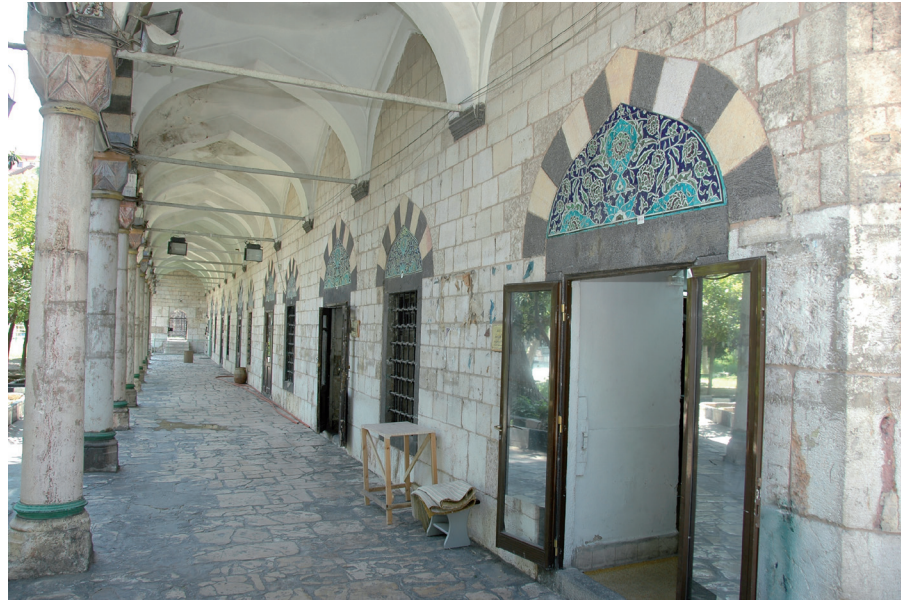
Figure 17. Portico of Tabhane in the west of the Mosque, view from north, 2009.

The main construction material used in the *Tabhane* blocks are yellowish-white fine cut stone. On the courtyard facades and vaults of the porticos black and white fine cut stones were laid alternatively. The columns of the porticos bear blue and red coloured diamond patterned capitals. The relieving arches on the windows and doors are decorated with patterned glazed tiles similar to those used in the Mosque. The interior walls of the

Tabhane are plastered and the domes which were originally covered with lead are now covered cement. The *Tabhane* has been abandoned since 2008 due to the renovation work (**Figure 9-11, 17**).

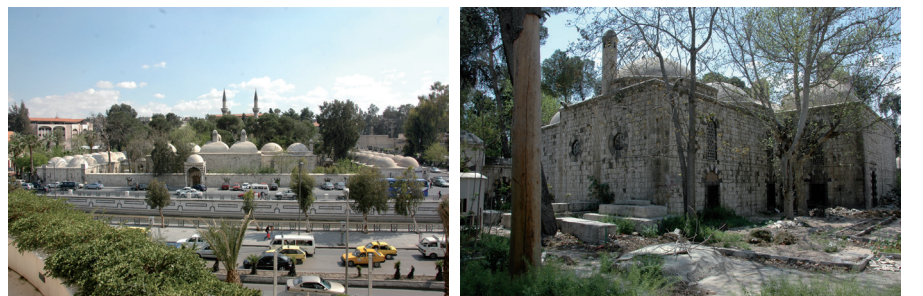
Figure 18. Imaret a) View from north, the Caravanserai masses on sides, b) View from the inner garden in the north-eastern corner, 2009.

The *Imaret*, which is placed to the north in the same axis with the Mosque, is a T shaped building block oriented in east-west direction. The northern side of the *Imaret* is bordered with a courtyard encircled with high walls that has a door opened to the Barada River. On the two sides the twin Caravanserais are located (**Figure 9- 11, 18- 19**).

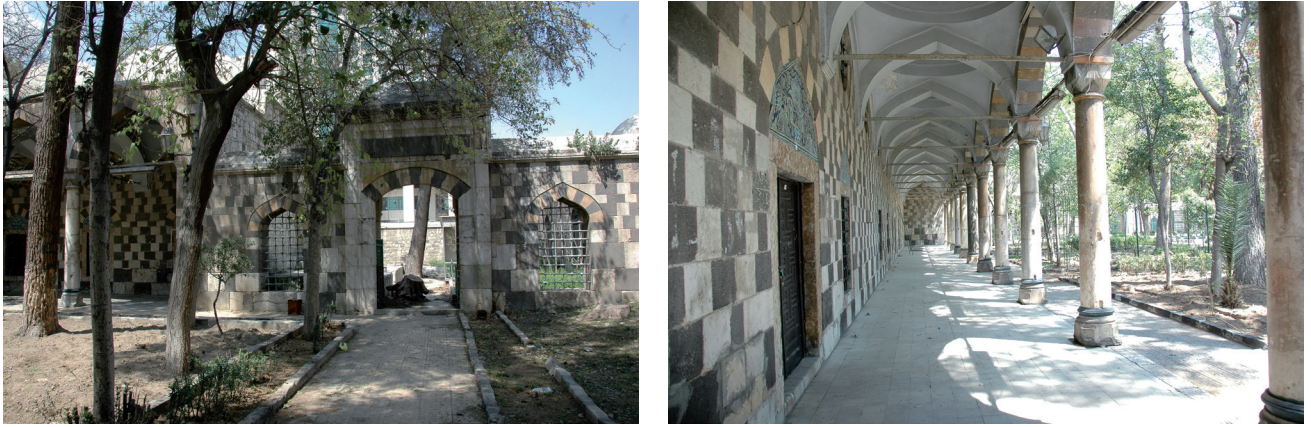
Figure 19. a) The eastern corner of Imaret facing towards the courtyard and the door leading to the rear courtyard, b) The facade of Imaret facing towards the courtyard with porticos, view from west to east, 2009.

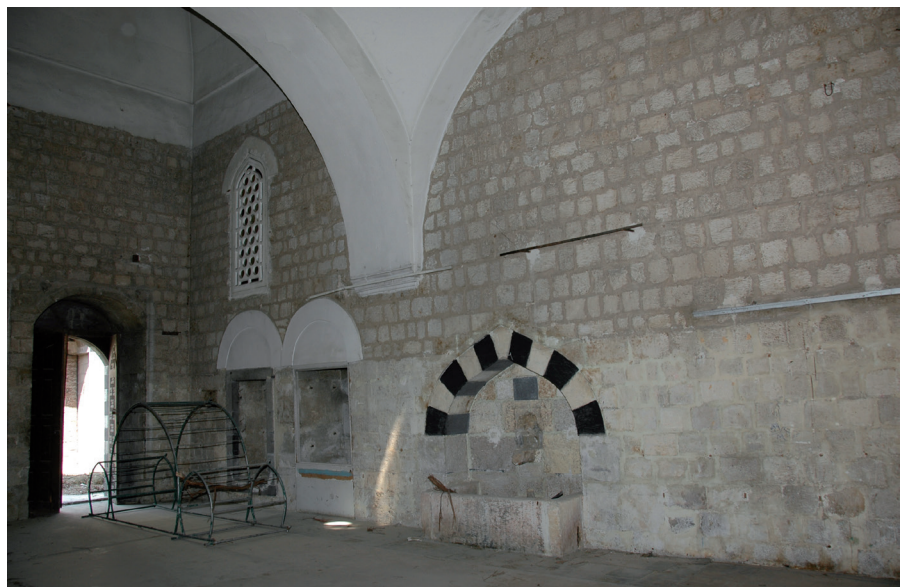
Figure 20. Imaret, the north-eastern corner of Aşhane space, 2009.

at the centre; the two spaces in the north are covered with a cross vault, while the other two spaces in the south are covered with two domes having lanterns on their tops (**Figure 20**).

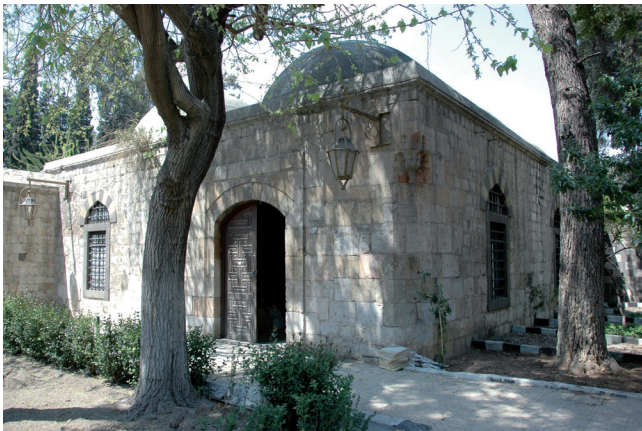
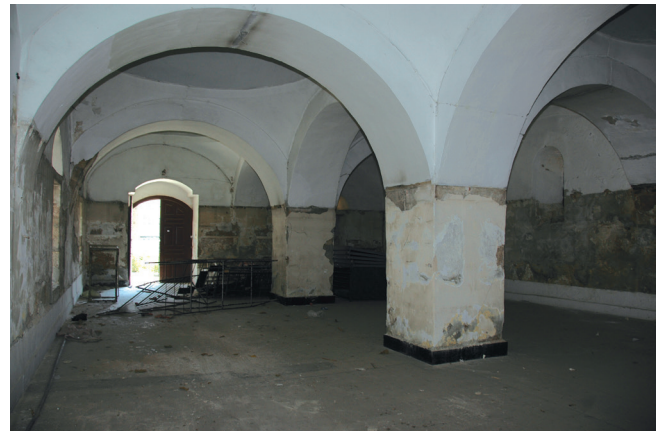
Figure 21. a) The courtyard entrance of Caravanserai block in the west of Imaret, view from south-eastern corner, b) View of the main entrance from the inside of Caravanserai block in the west of Imaret; windows faced to the courtyard on the left side and windows faced to outside on the right side, 2009.

The Caravanserai blocks are rather modest, rectangular buildings placed in the north-south axis in both sides of the *Imaret*. The twin Caravanserais which are connected symmetrically with the *Imaret* through the courtyard walls are divided longitudinally into two main naves with six piers located at the central axis and each nave is covered with seven small domes, supported with pendentives. Kuran (1986, 71) states that this double-naved configuration resembles the plans of Şehzade Mehmet Caravanserai and the Caravanserais of Gebze Çoban Mustafa Paşa Complex (**Figure 9-11, 21**).

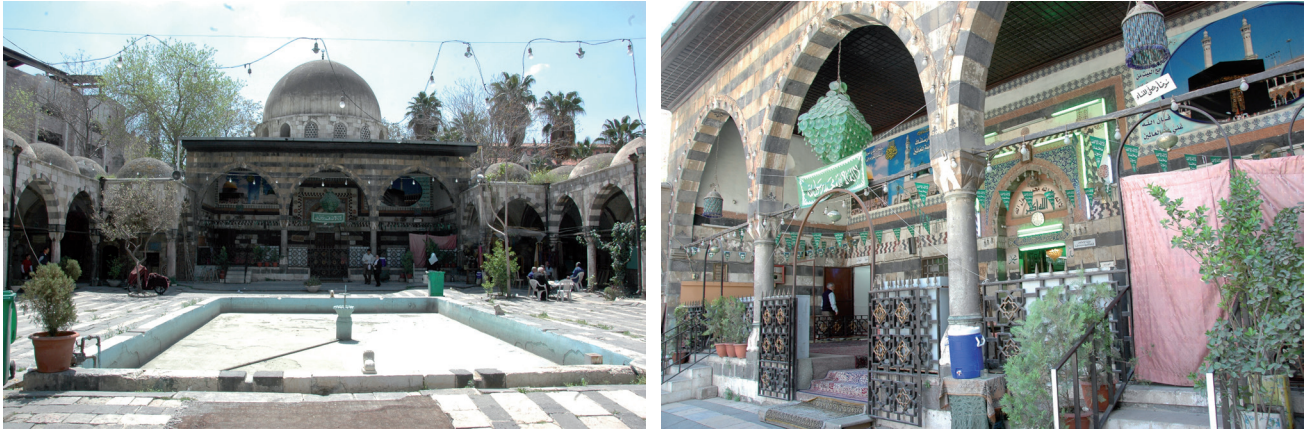
Figure 22. a) View of the Classroom of Madrasa and the pool at the courtyard from the entrance, b) View of portico in front of the Classroom from west, 2009.

The “Taqiyah” was inserted to the eastern end of the pedestrian way which intersects the Complex in east-west axis (**Figure 9- 11, 22- 3**). The Madrasa which has a symmetrical order that is defined by the classroom and a three domed portico at the axis of the entrance door is formed by the cells that surround the courtyard in three sides and the single naved and domed portico placed in front of them. The classroom, which is defined as *semahane* by Aslanapa (1986, 236- 7) and as *semahane* and *masjid* by Kuran (1988, 169), is located in the entrance in the north-south axis. The entrance to the Madrasa is from the *Arasta* through the main door located at the north. There is a rectangular pool similar to the one in the Suleymaniye Complex in the middle of the courtyard (**Figure 23**).

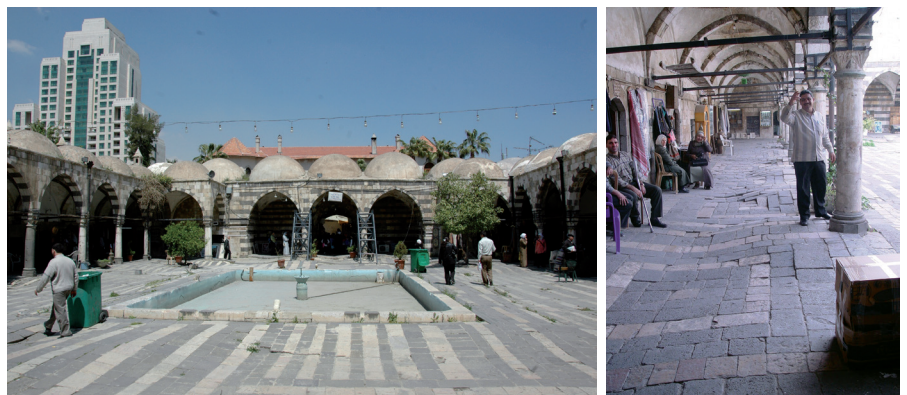
Figure 23. a) View of entrance portico of Madrasa from south, 2009, b) Portico of Madrasa, the collapse in the pavement at the west wing, 2005.

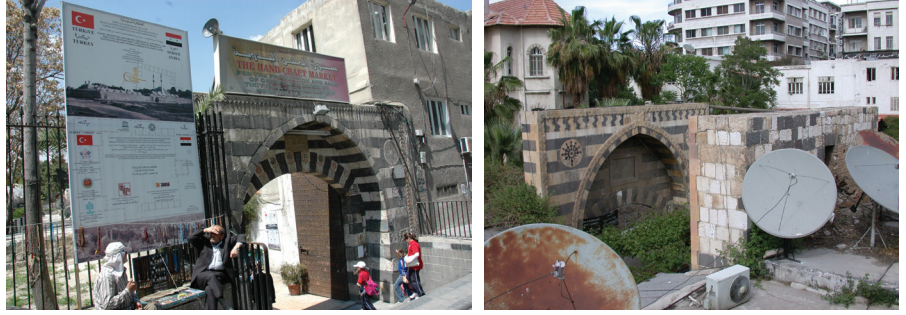
Figure 24. a) Main East Gate of Arasta leading to street, b) Intermediary gates of Arasta: the one on the left hand leads to the Ministry of Tourism in the north and the other on the right hand gives access to the Madrasa in the south, 2005.

There are totally twenty-two cells, fourteen of which are in the east and west wings, six in the northern entrance and two in both sides of the classroom. The Madrasa cells which are connected with the courtyard via a door and a window are covered with domes, while the ones in the north-eastern and north-western corner attached to the *Arasta* are covered with flat roofs (Figure 24-25). At present the cells serve as handcraft goods shops and workshops.

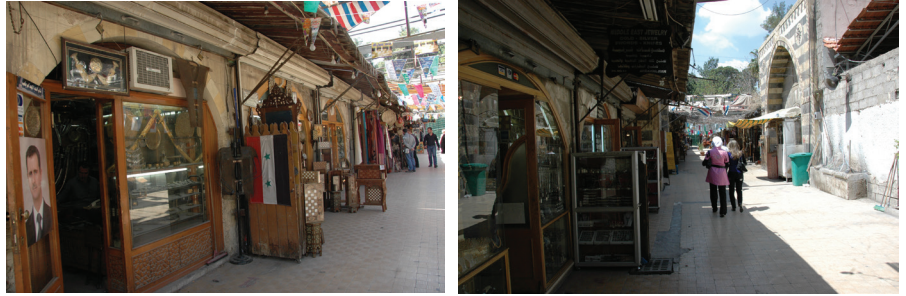
Figure 25. a) The vaulted shops in the south-west of Arasta, b) Intermediary gate of Arasta gives access to the Madrasa in the south, 2009.

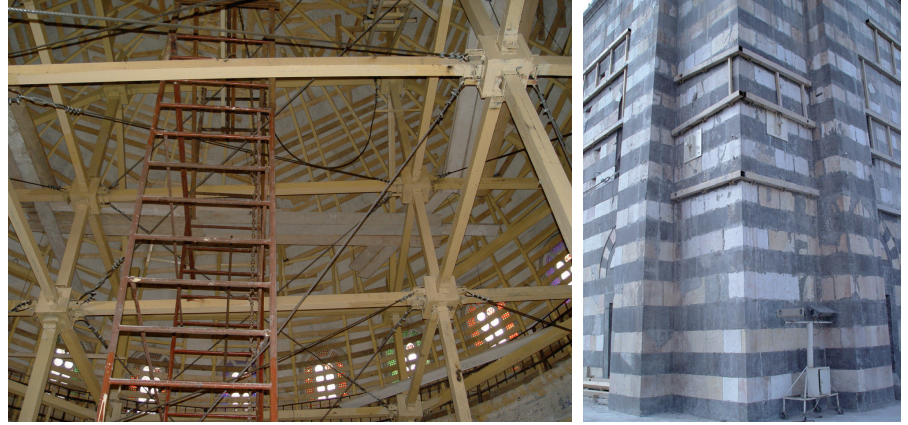
Figure 30. a) Steel framework system supporting the dome of Süleymaniye Mosque, b) Metal supports at the southern (kibla) wall of the Mosque, 2005.

In order to prevent further damages in the dome and disintegrations in the south and west walls of the Mosque, which is caused by collapses in the floor, the south and west walls of the building were enclosed within steel beams and profiled iron bands and a temporary support scaffold was installed inside the building (Figure 30). On the other hand, the damaged walls of the Mosque were tried to be reinforced by injecting great amount of cement mortar inside them via small holes of 3-4 cm in diameter (Figure 31). However, according to the local authorities, after this application, disintegrations and inflations occurred on the wall surfaces. Within this course, no structural intervention was held in the *Imaret*, *Tabhane* and Caravanserai units which did not have any important problem, but the stone masonry walls of the buildings underwent pointing with cement based mortar. The interior spaces were plastered with similar mixtures and majority of the window and door frames were renewed.

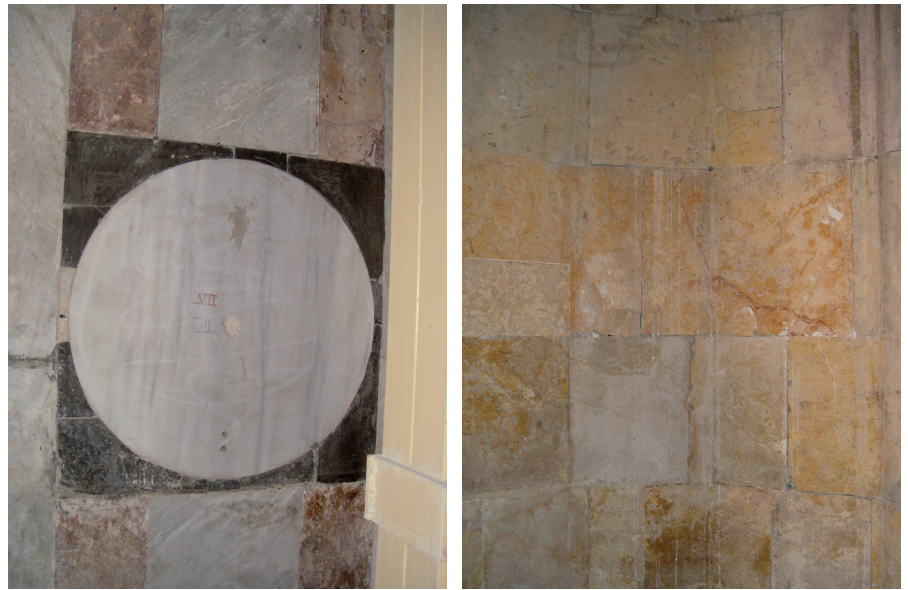
Figure 31. Holes for injecting mortar on the interior walls of Süleymaniye Mosque, 2005

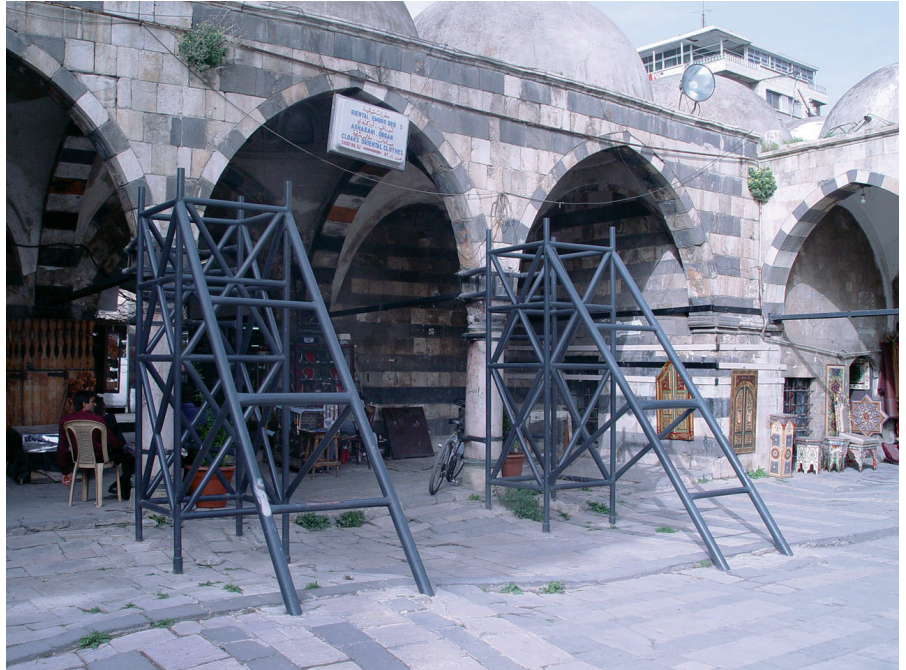
Figure 32. Supporting scaffold at the entrance portico of Madrasa, 2005

In 2000s, the changes in the ground of the Complex caused great damage in the Mosque and the Madrasa. Collapse in the ground affected especially the north and north-eastern wings, the courtyard and the portico of the Madrasa causing instability in the superstructure, cracks and disintegrations. The west wall slightly shifted from its axis. There have been vital subsidence and collapses in the stone paved ground of the courtyard too. A temporary measure was taken by building a buttress at the facade of the entrance portico which faces to the courtyard (**Figure 32**). These problems in the Madrasa caused structural problems in the *Arasta*; fractures and disintegrations occurred in some of the doors and the shops in the *Arasta*.
