SEISMIC RETROFITTING PROPOSAL FOR MODERN HOUSING HERITAGE: THE CASE OF CINNAH 19 IN ANKARA (1)

Cengiz ÖZMEN*, Ceren KATIPOĞLU ÖZMEN**, Ayça ÖZMEN**, Emre KİSHALI***, Vildan ERASLAN****, Esra Nur Eda KÜÇÜK**

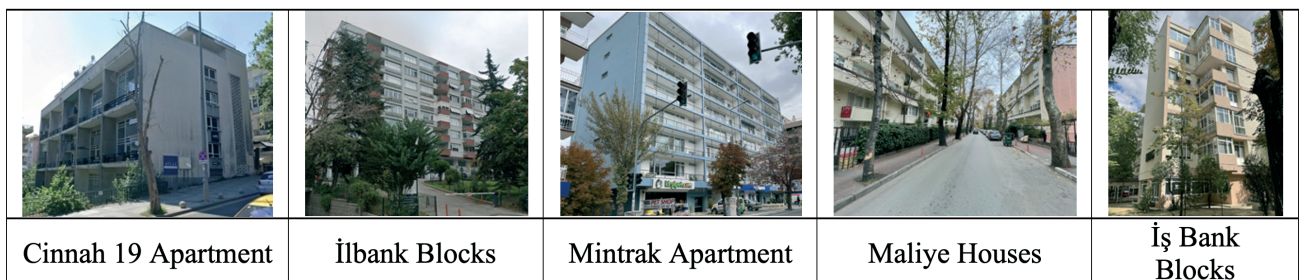
Figure 1. Some examples of the modern housing blocks in Ankara (Authors, 2022).

The International Style that emerged in the first half of the 20th century and became widespread after World War II, along with the modern architectural movement, found fertile soil in Türkiye. The nation's rapid urbanization in the 1950s drove the need for housing, and some of this need was met by mass housing cooperatives. Even though they did not have very high capital, those cooperatives achieved a relatively high level of organization in the 1950s. Batuman (2017) defines this period as the Civil Cooperative Period. After the Law on the Amendment of Article 26 of Land Registry No.6217 (Resmi Gazete, 1954), the construction sector, which was dominated by actors with low capital and small companies defined as builders, rapidly increased housing production. During this period, architects working in Türkiye produced housing blocks with the characteristics of the modern architectural movement and international style, forming a valuable part of today's architectural heritage. Among these structures, many examples have survived and maintained their original usage such as Cinnah 19 (1955), Israil houses (1955), İlbank Blocks (1957), Mintrak Apartment (1957), 96'lar Apartment (1957), Maliye Houses (1957) and İş Bank Blocks (1962). (Figure 1).

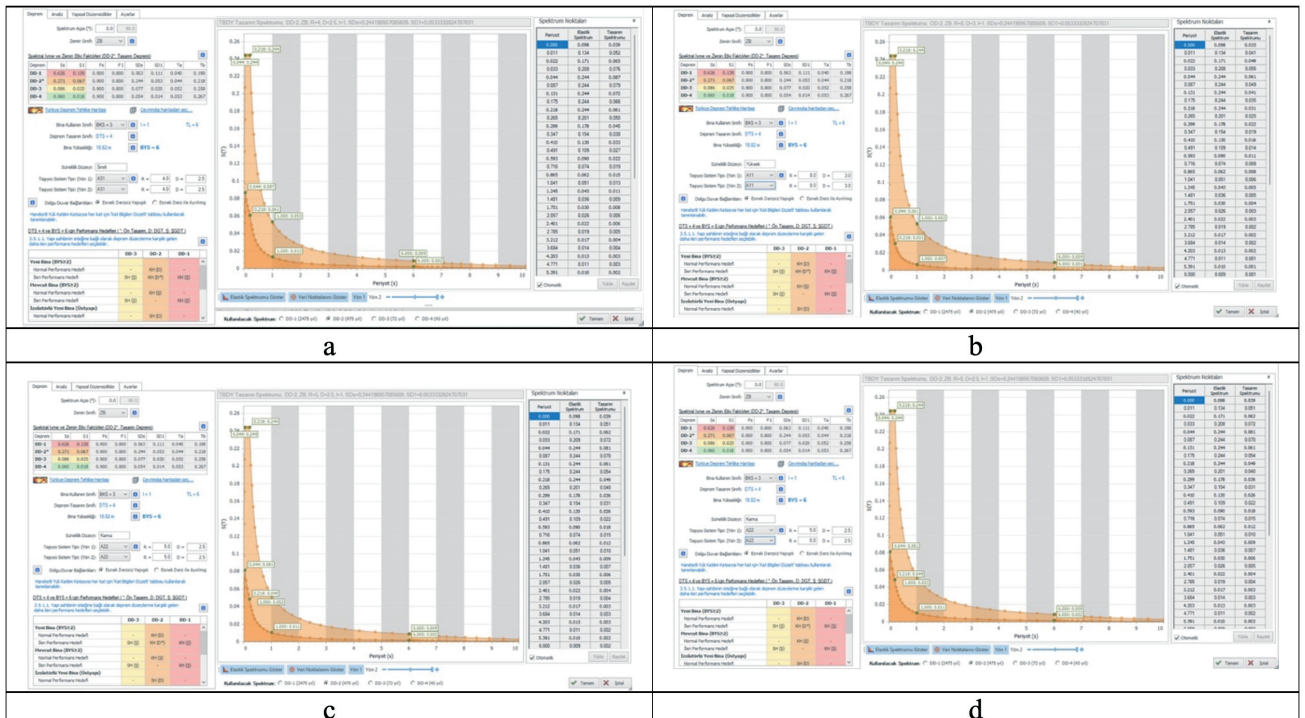
Figure 12. a. The Horizontal Elastic Design Spectrum for the model 1. b. The Horizontal Elastic Design Spectrum for the model 2. c. The Horizontal Elastic Design Spectrum for Model 3. d. The Horizontal Elastic Design Spectrum for the model 4 (Tables are produced via ProtaStructure Software).
