## SUSTAINABLE CONSERVATION ISSUES OF FOUR 14TH AND 15TH CENTURY MOSQUES IN ANKARA: AHI ELVAN MOSQUE, ÖRTMELİ, SABUNÎ AND POYRAJLI MESJIDS

Evin ERDER

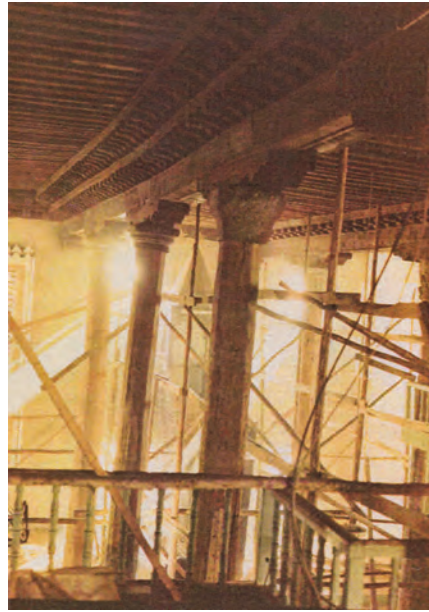
**Figure 7.** Ahi Elvan Camii maintenance and repainting campaign in 1970s (VGM Archives).

**Figure 8.** Ahi Elvan Camii, during fire at adjacent shops in 1985 (VGM Archives).

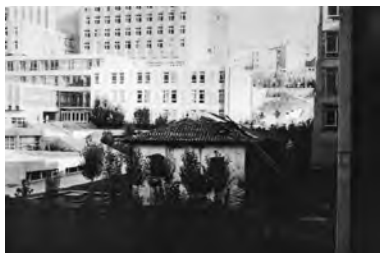
**Figure 9.** Poyraji Mesjidi before its registration and restoration in 1970s (VGM Archives).

Poyraji Mesjidi was restored completely by VGM between 1971 and 1975 (25). In an old photograph, taken prior to its restoration in the 1970s, its walls were timber-frame with mud brick infill. This *mesjid* also had stucco window frames with stained glass windows, later replaced in the 1970s by cast concrete windows similar in form and appearance to their originals (26). In 1971, during the construction of the Hacettepe University campus, a report by two art historians, Bilcen and Bayburtluoğlu, dated September 8, 1971, requested the registration of this structure as an historic monument (27). The report declared that the most valuable part of the *mesjid* was the timber projection of its women's section, or *kadınlar mahfeli*, and its *kalem işi*, or pigmented embossments. At the time, its *aşı boyası* or natural pigments had "different tones of green, orange, yellow, white, turquoise and *vişneçürüğü* (cherry red)" (28). Its timber ceiling also featured *kalem işi* which "perfectly reflecting the taste of their time" (29). This report thus ensured the registration of Poyraji Mesjidi as an historic monument worthy of protection and conservation. As a result, on September 15, 1973, Gayrimenkul Eski Eserler ve Anıtlar Yüksek Kurulu (Committee for Immovable Historic Works and Monuments) decided that Poyraji Mesjidi would be restored (30). Its restoration involved partial removal and replacement of its deteriorated mud bricks and tie-beams and re-plastering of the building entirely with cement-based cladding as well as replacement of its timber ceiling with a new one resembling its original.

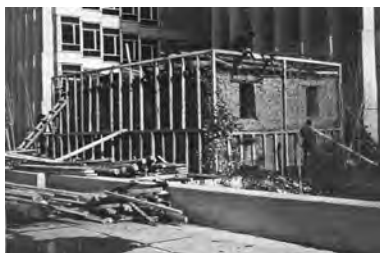
**Figure 10.** Poyraji Mesjidi during its restoration in the 1970s (VGM Archives).

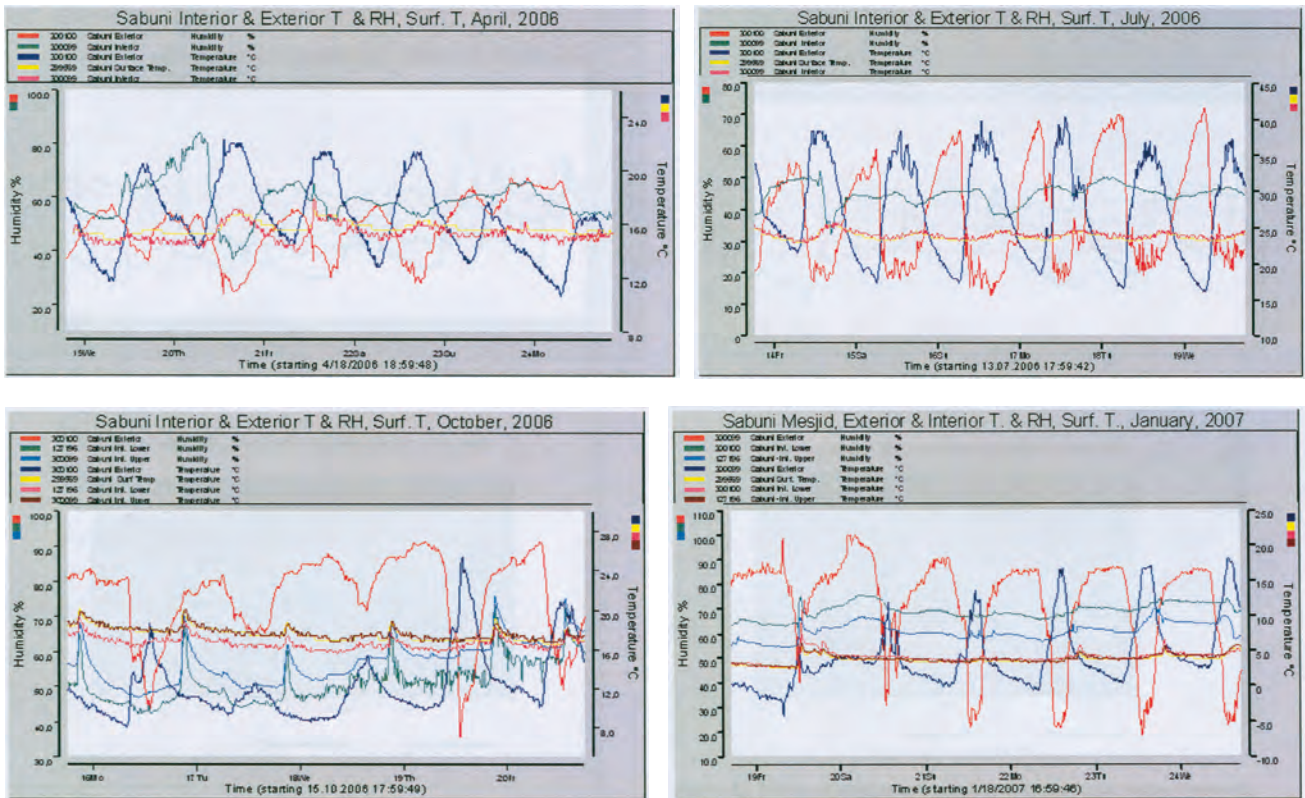
Microclimatic data were recorded for all four structures during each season. Provided here are the results for one of the mesjids, Sabunî Mesjidi (Figure 16-19). These data were analyzed at each structure per season in order to ascertain whether existing micro- and macro-climatic conditions may have a detrimental effect on the structures themselves, with particular emphasis on their timber elements. Data collected during a one year period consisted of ambient temperatures and relative humidity inside each structure, near their timber ceilings, the surface temperature of their ceilings and temperature and relative humidity variations outside each structure for a one week period per season.

**Figure 16.** Exterior and interior temperature and relative humidity and surface temperature of ceiling at Sabunî Mesjidi during April.

**Figure 17.** Exterior and interior temperature and relative humidity and surface temperature of ceiling at Sabunî Mesjidi during July.

**Figure 18.** Exterior and interior temperature and relative humidity and surface temperature of ceiling at Sabunî Mesjidi during October.

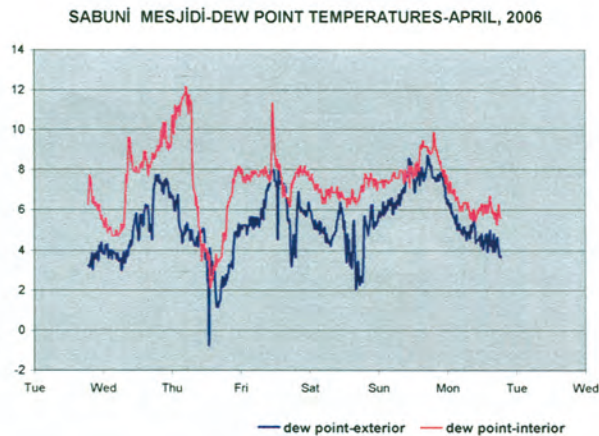
Figure 22. Sabunî Mesjidi, exterior and interior dew point temperatures in April.

Mesjidi during April showed that their interior dew point temperatures varied depending upon the physical characteristics of their bearing walls. When the data from all three structures were compared, at Ahi Elvan Camisi the dew point temperature varied the least and at Sabunî Mesjidi the most (Figure 20-22).

However, a comparison of the differences between mean exterior and interior dew point temperatures also suggested that overall, Sabunî Mesjidi's bearing walls with clay-based renders provide a more effective

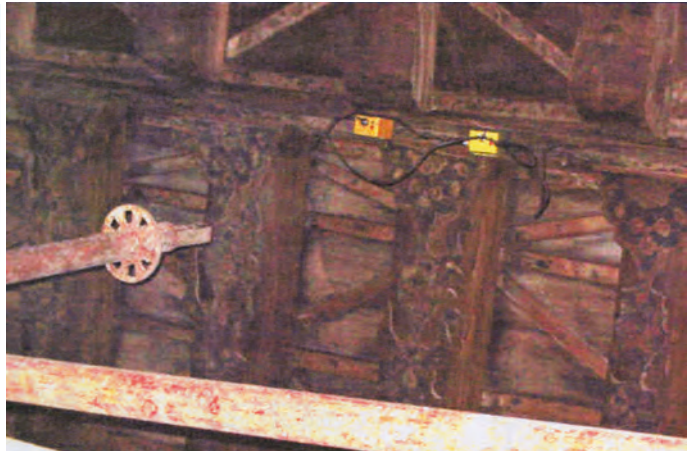
Figure 25. Örtmeli Mesjidi, difference between interior temperature and surface temperature at ceiling and dew point temperature in January, 2006.

Figure 26. Tiny tag® data loggers at ceiling of Örtmeli Mesjidi in January, 2006 during restoration work (Photo: E.Erder).

Micro-environmental data at Örtmeli Mesjidi in January, during its restoration work, confirmed that the restoration of this historic building in the winter became problematic. Data gathered by Tiny tag® data loggers placed adjacent to the timber ceiling and within the main prayer hall of Örtmeli Mesjidi revealed the risk of condensation along with temperature fluctuations due to the temporary heating system (Figure 25, 26). It was therefore likely that dust from the construction and re-plastering work adhered to the original *kalem işi* decorations, complicating their re-painting. These observations therefore clearly implied the necessity for greater care in the timing of conservation interventions and restoration work at these and other similar structures.

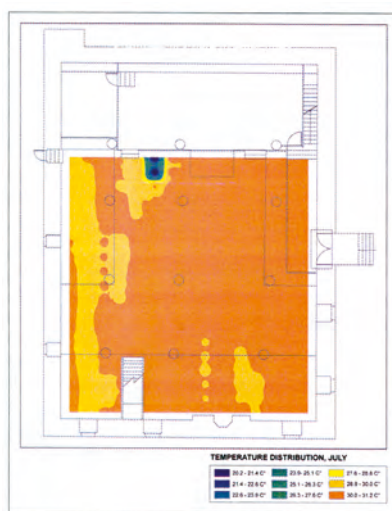
Figure 27. Temperature distribution at Ahi Elvan Camii in July, 2006.

decreased. The mapping also revealed that in July, at Ahi Elvan Camisi, temperatures remained constant throughout the structure when its interior was most affected by exterior climatic conditions (**Figure 27**), and Sabunî Mesjidi was the least affected (**Figure 28**). Whereas in January, at Sabunî Mesjidi, constant low temperatures prevailed within when the structure was most affected by the cold winter climate (**Figure 29**).

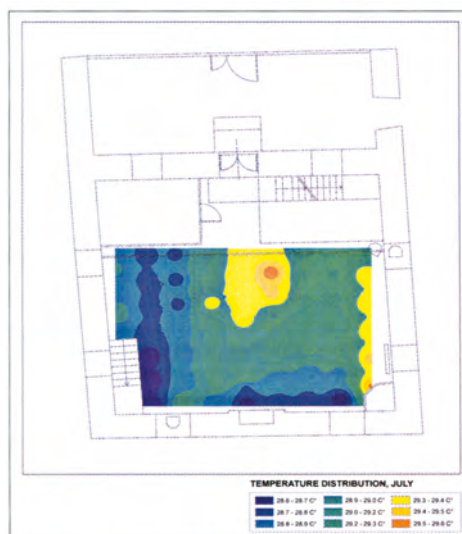
Figure 28. Temperature distribution at Sabunî Mesjidi in July, 2006.

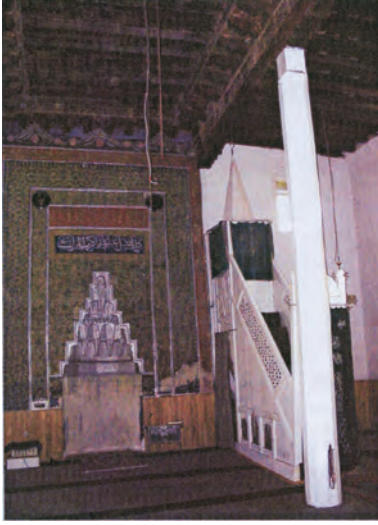
Figure 30. İlyakut Camii re-painted cast stucco mihrab (Photo: E.Erder).
